Frederick Flood Damage Report

Road Name: Godding Hollow Parkway (WCR 18) between East Frontage Road and Silver Birch (WCR 11)

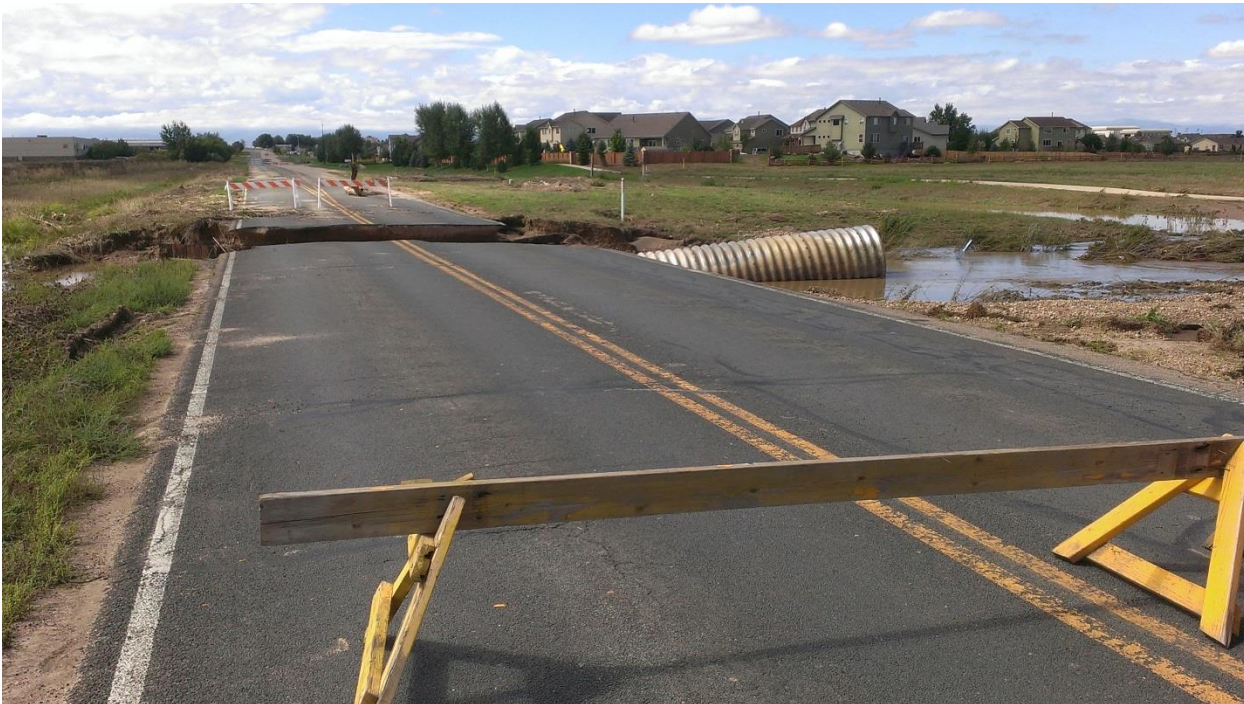
Current Damage/Condition: Approximately 225' of damaged roadway including a 30' length of the entire width of the road washed out and needs to be replaced.

Drivable: No

Repair Proposal: The road will be replaced to its previous condition with the addition of a box culvert that will be able to handle the 100 year storm event. This section design would be based on the one planned for the Godding Hollow Project from Colorado Blvd. to the East Frontage Road that has been on the Capital Improvement Plan.

There is no reasonable interim fix available for this road due to the extensive repairs necessary.

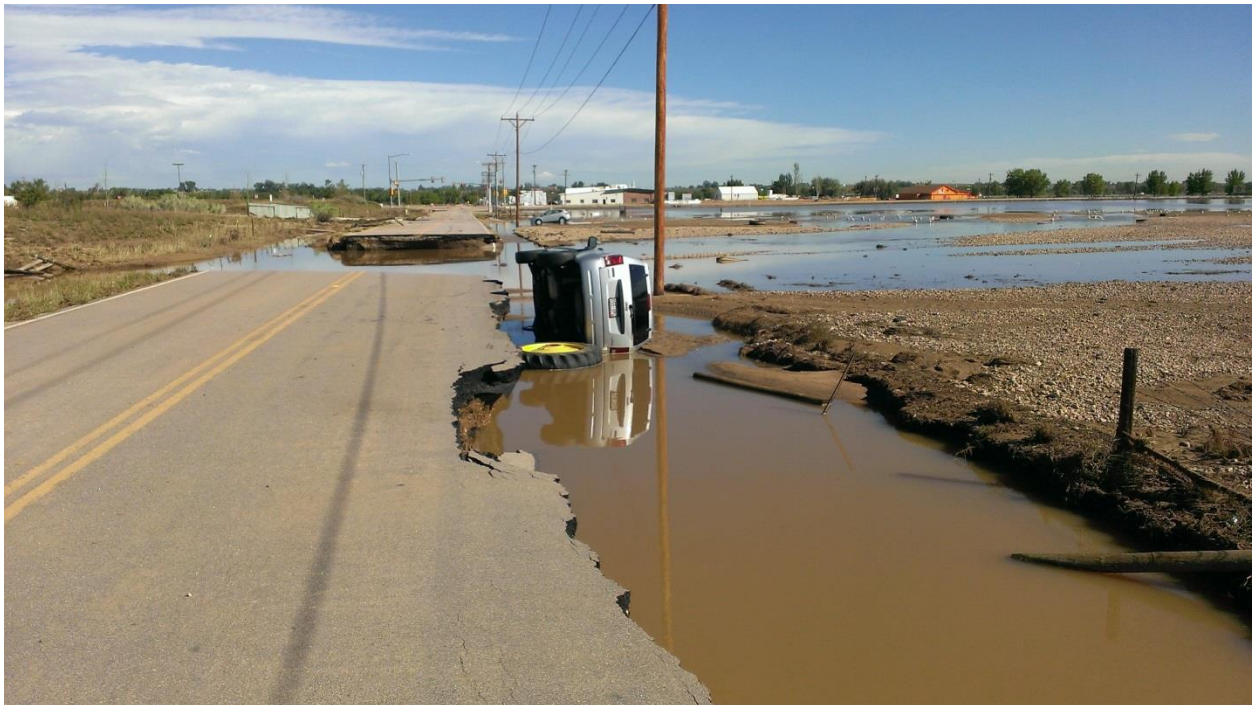
Road Name: Aggregate Blvd (WCR 7) from approximately WCR 20.5 to Highway 119

Current Damage/Condition: Approximately 1100' of damaged roadway including various sections of the roadway washed to varying extent. These and other sections may need to be replaced.

Drivable: No

Repair Proposal: An interim emergency repair is proposed to make the road passible to traffic while the final design is prepared. The interim repair would consist of backfilling the washed out areas with structural fill and road base to final grade. The interim repairs will be incorporated as much as possible into the final improvements.

The road will be replaced to its previous condition with the addition of storm drainage improvements cable of accommodating the 100 year storm event.

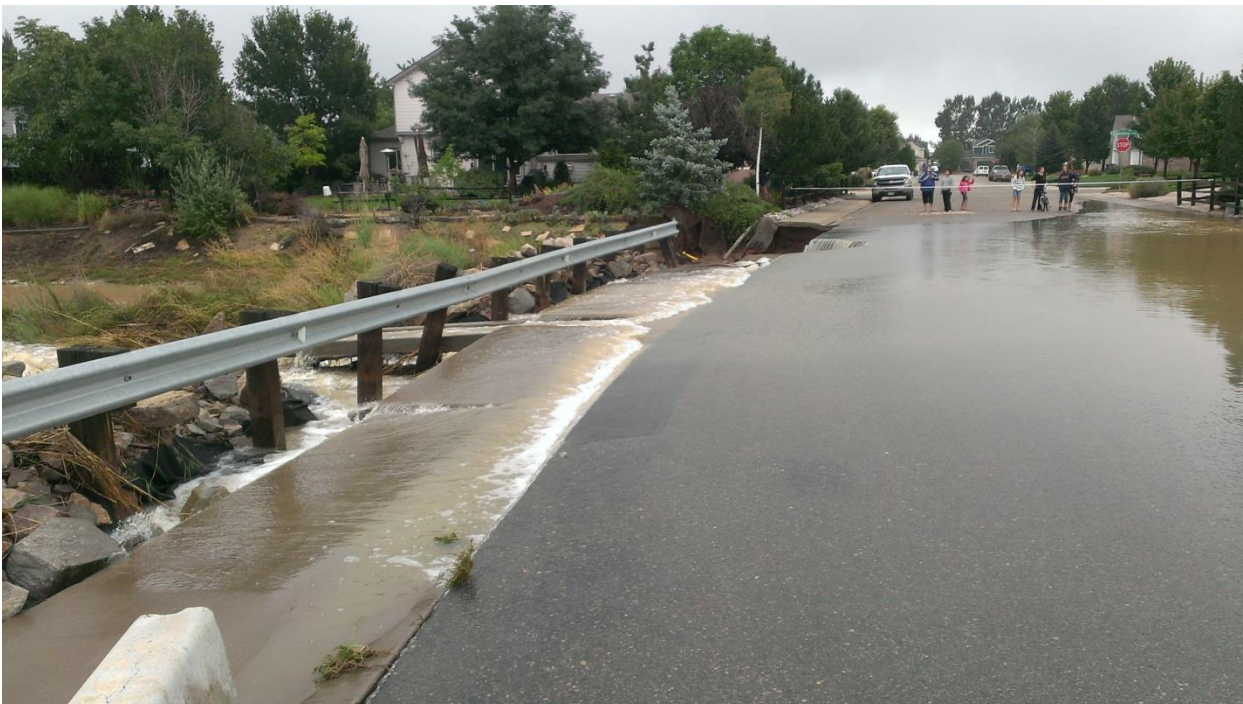
Road Name: Wetlands Loop between W. Conservation Drive and Wetlands Drive

Current Damage/Condition: Approximately 220' of sidewalk and damaged roadway including 43' of the roadway washed out leaving it impassable.

Drivable: No

An interim emergency repair is proposed to make the road passible to traffic while the final design is prepared and repairs to Bella Rosa Pkwy/WCR20 are constructed. This route is necessary as a detour to Bella Rosa Pkwy/WCR20 during that project. The interim repair would consist of backfilling the washed out areas with structural fill and road base to final grade and installation of concrete barrier along the area of the washed out sidewalk.

The road section needs a complete overhaul including verification that a new design can handle the 100 year storm as well as ensuring that neighboring property will not be flooded with this design.

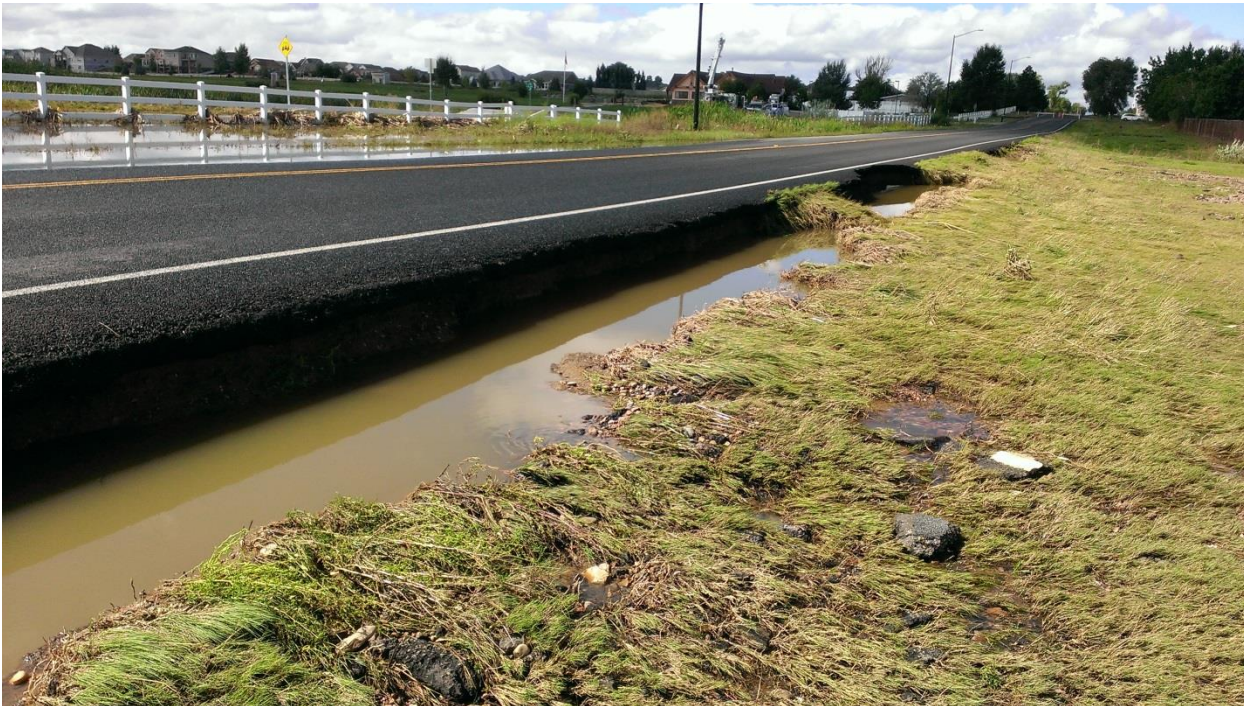
Road Name: Bella Rosa (WCR 20) between Conservation Drive and Wetland Drive

Current Damage/Condition: Various sections of the road were washed out and undermined. The Town was able to make an interim emergency repair to allow traffic to continue on the road after it was deemed temporarily safe.

Drivable: Yes

Repair Proposal: The road will be replaced to its previous condition with the addition of a box culvert that will be able to handle the 100 year storm event. This section design would be based on the section included in the Capital Improvement Plan.

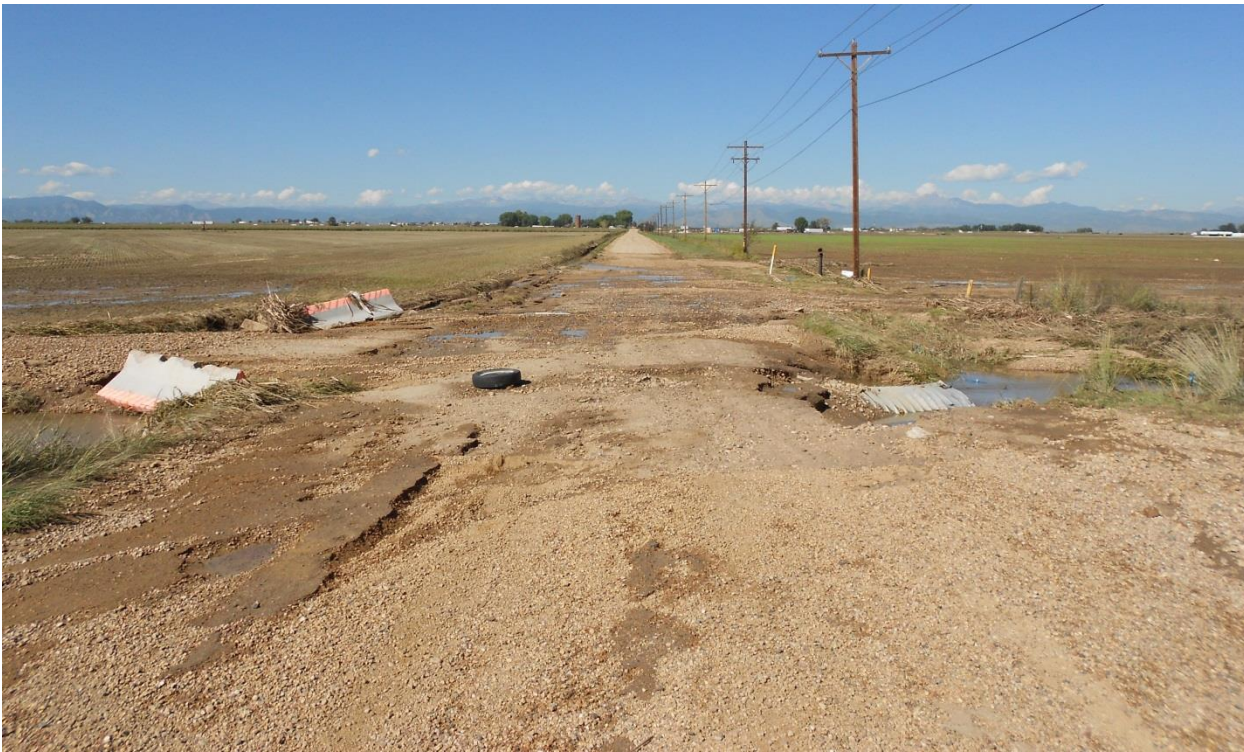
Road Name: Tipple Parkway (WCR 16) between East Frontage Road and Eagle Blvd.

Current Damage/Condition: The road section was washed out leaving it impassable. One of the oil and gas entities made interim emergency repairs to the road section but it still needs further repairs.

Drivable: Yes

Repair Proposal: The road will be replaced to its previous condition with the addition of a box culvert that will be able to handle the 100 year storm event. This section design would be based on the section included in the Capital Improvement Plan.

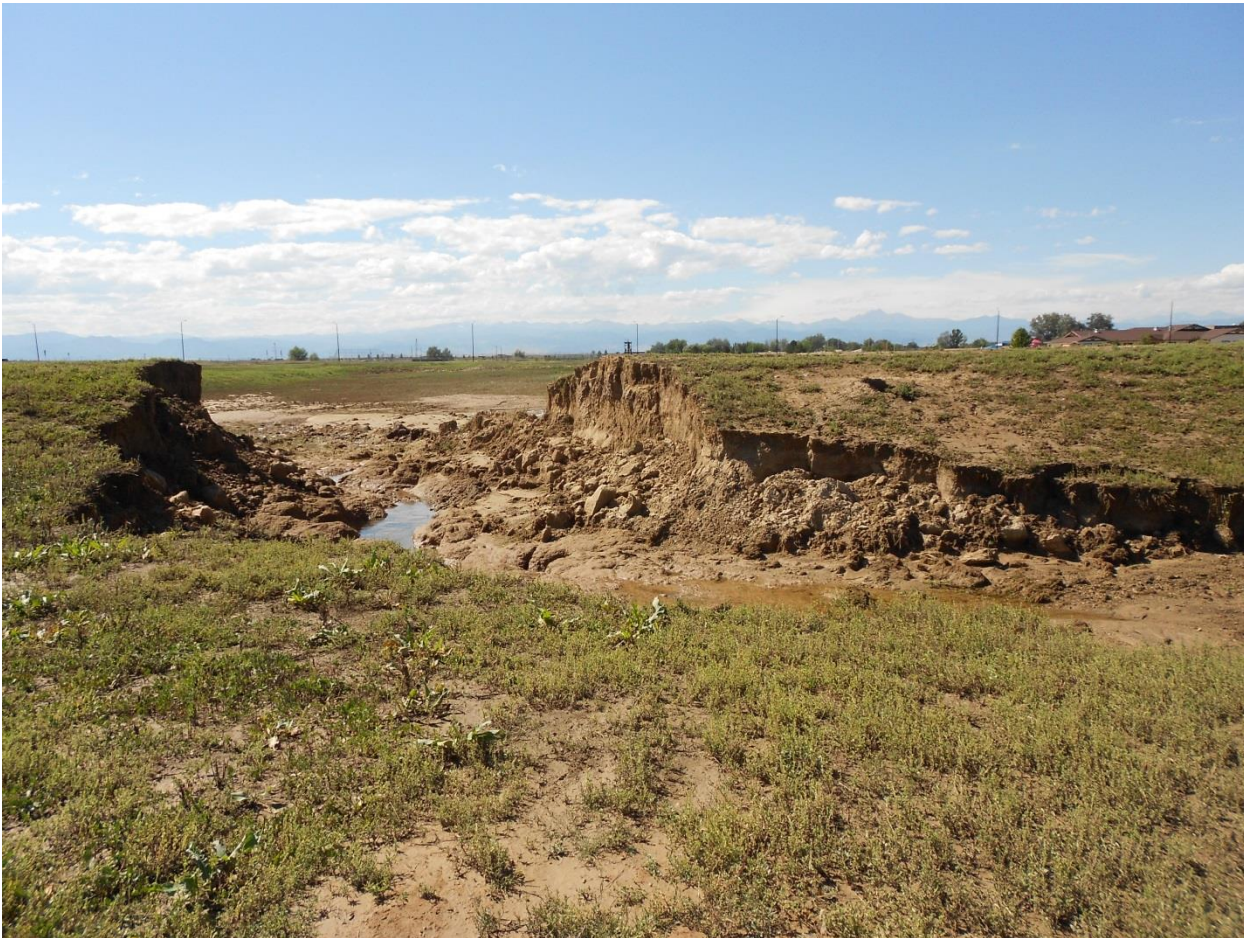
Facility Name: Stormwater System

Current Damage/Condition: Two stormwater basins between WCR15 and Frederick Way Breached.

Functioning: No

Repair Proposal: The basins need a complete overhaul including reconstruction of the breached walls and verification of capacity for a 100 year storm.

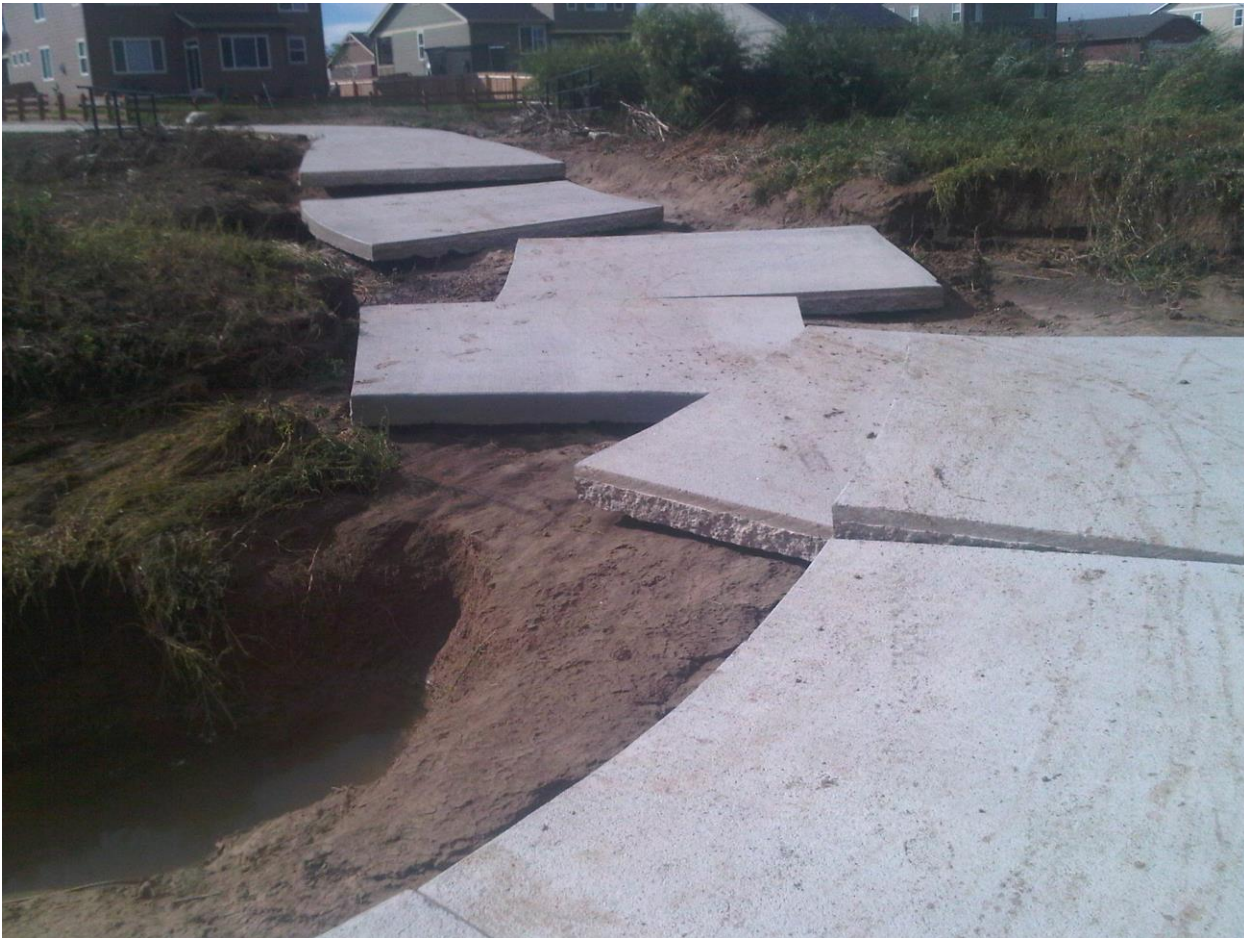
Road Name: Sidewalk sections

Current Damage/Condition: Various sections of sidewalk have been damaged including the northern trail connection between Raspberry Hill and Eagle Valley.

Walkable: No

Repair Proposal: The sidewalk section need to be replaced to restore trail connectivity.
